Some notes regarding Mann House and Library insulation

External thermal images were captured March 26, 2018, between 5:44 to 6:09 AM (sunrise at 6:40 AM). Outside temperature was approximately 15°F under clear sky and low wind speeds. Inside thermostat set for 60°F; actual inside temperatures were not measured.

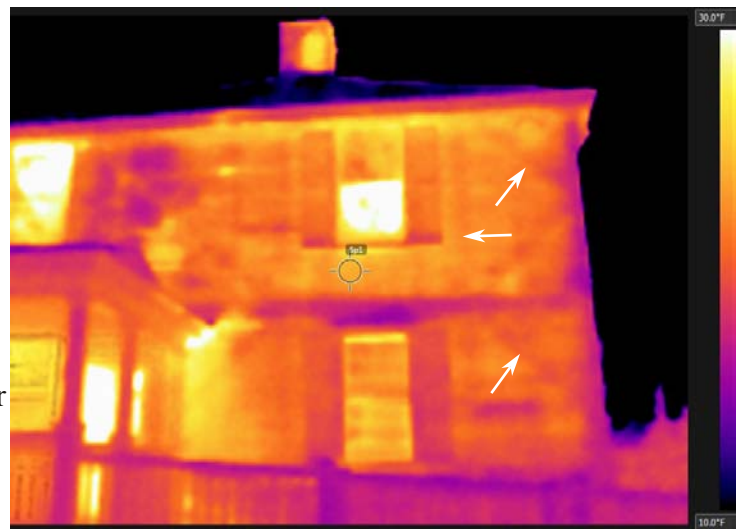
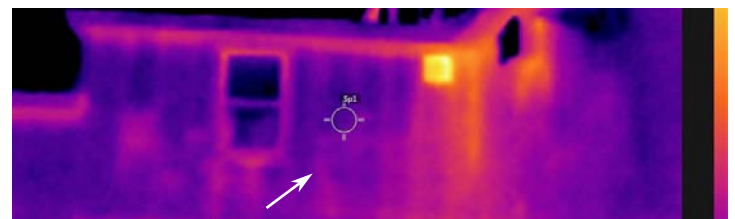
Starting at the left (main entrance) side we see that the areas over studs and diagonal braces (see white arrow) are cooler (darker) than the areas over cavities. This shows that the cavity insulation is poorer than solid wood - a clear indication of missing insulation in the cavities. *Note: the shutters must be ignored because they are decorative pieces attached to the outer wall but not part of it.*

Compare that with the back side of the upper library's wall (lower image) where the studs are clearly warmer while the sections between are clearly colder - indicating well insulated wall cavities.

Thus it appears that neither the first nor second floor walls of the main building contain insulation, at least on this side.

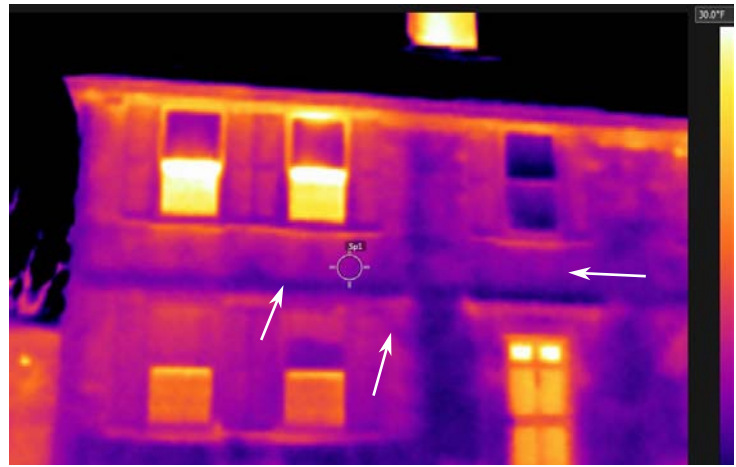
The front side of the main building is harder to interpret - much of the area is covered by shutters making it difficult to see a pattern of studs.

Nonetheless, a pattern can be seen of cooler outer walls where the wall top-plates and the diagonal braces (to the left of the door, above and below the 2nd floor) - see white arrows - provide better insulation than the cavities.

Again this indicates a lack of cavity insulation in the main building's front.

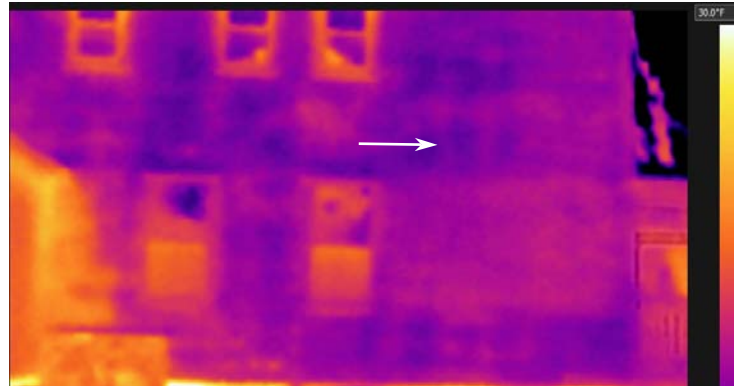
However, at the rear of the main building the pattern is reversed - now we see warmer (less well insulated) areas over the studs and cooler (better insulated) areas over the cavities, suggesting that insulation may have been blown into those cavities!

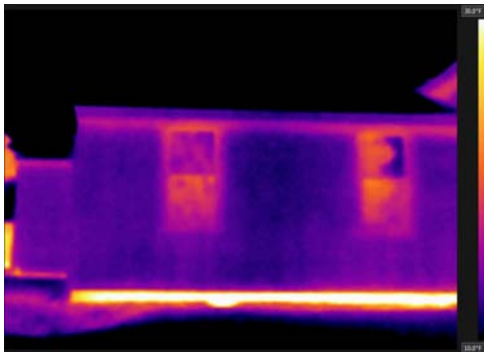
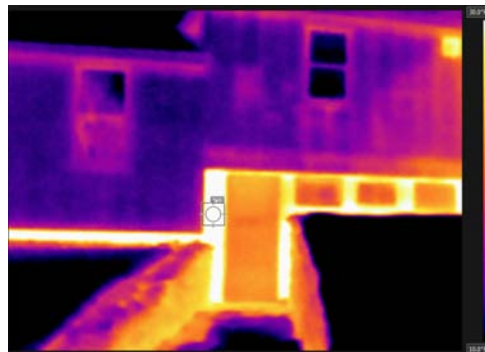
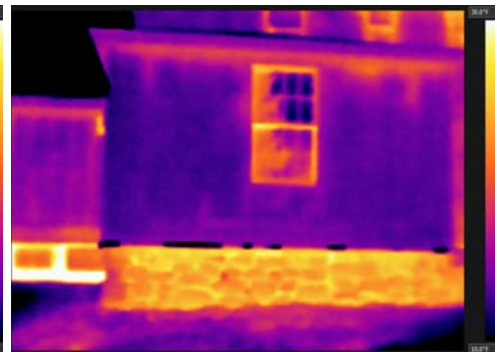
In contrast, the Library parts of the building all seem well insulated: warm over the studs and cold over the cavities,

indicating insulated wall cavities.

One item to note: the masonry areas, whether concrete or stone, are much warmer, indicating substantial heat losses - not surprising as both materials conduct heat well. While a properly insulated wood frame construction, even one built to 1950s specifications, would have a wall insulation value of at least R7 to R11, an 8" thick concrete wall provides only R1 - around 1/7 to 1/11 as effective as the wood frame wall!

In the image of "*Library, rear center*" above, the masonry hotspot next to the door measures 33°F, while the center of the door is at 21°F and the wood frame construction walls above range between 12°F to 14°F (with smaller areas up to 17°F). Hot exterior walls can only stay hot by letting a lot of heat flow outwards...

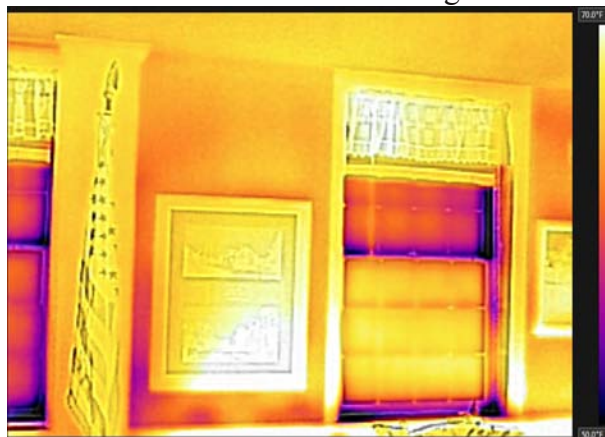
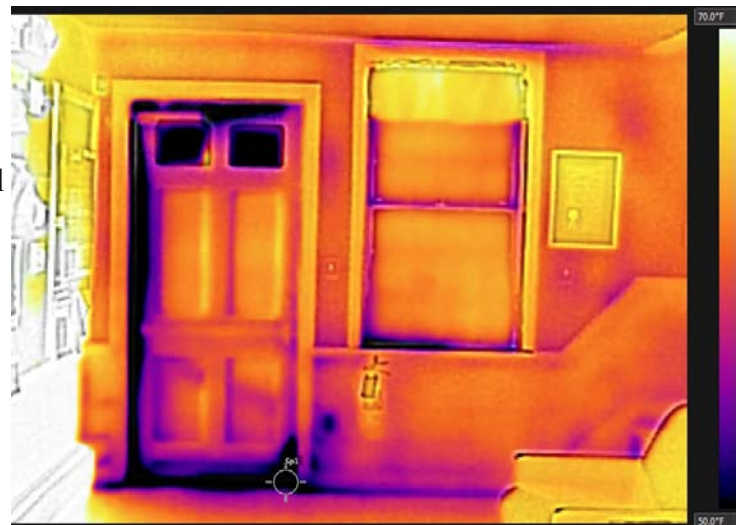
Main entrance to Mann House, meeting room:

This shows a common problem in both the Mann House and the Town Hall - defective weatherstripping. The temperature at the door's lower right corner is 36°F due to cold outside air leaking in. Not only does this cold air cool down the room, but it also allows an equal volume of heated air to leave the building elsewhere.

This wall and the stairwell to its right are somewhat cooler

than the other outside wall (image at left) - which is well heated by baseboard heaters.

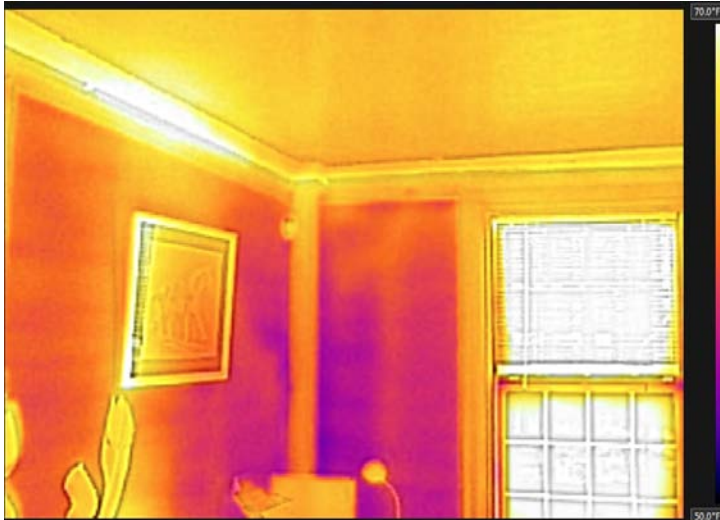
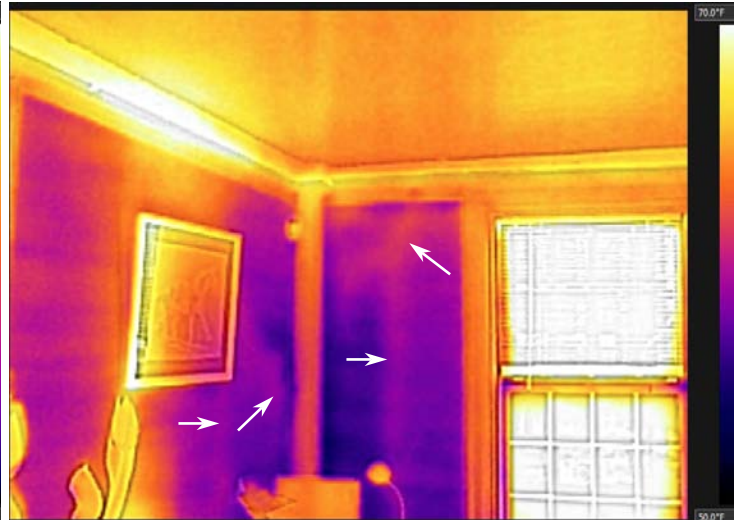
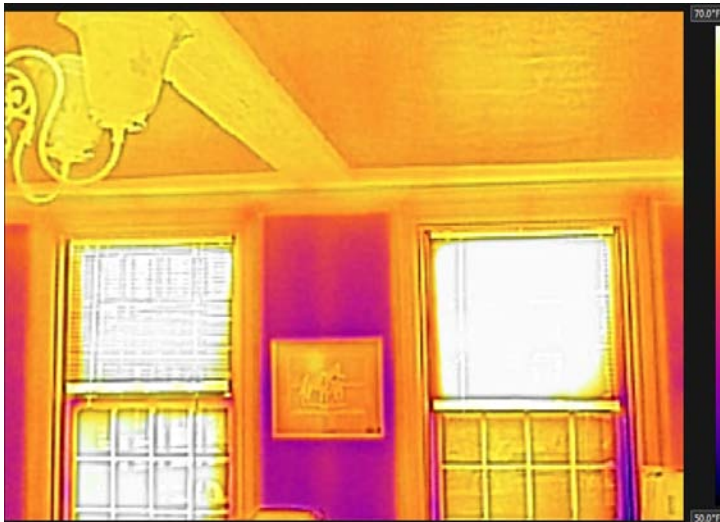
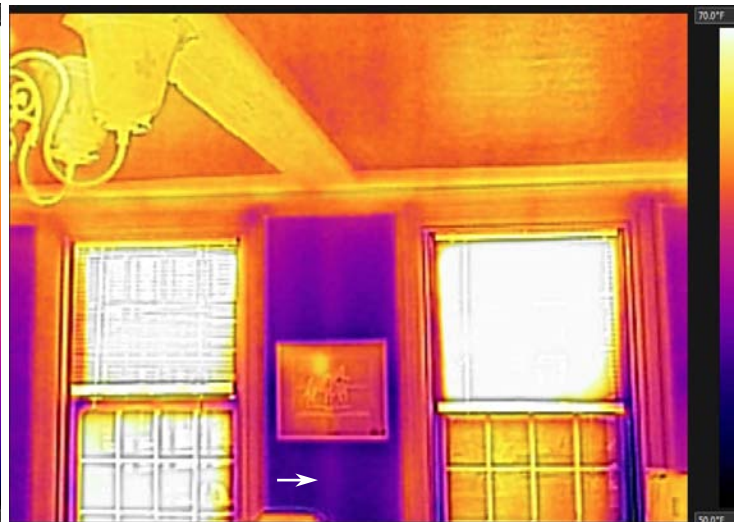
Selectmen's office:

There is evidence of poor cavity insulation - see white arrows pointing to warmer studs/braces than cavities

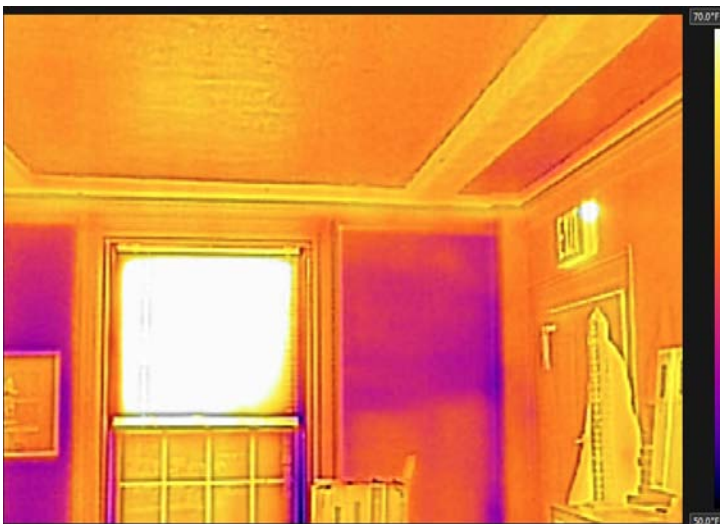
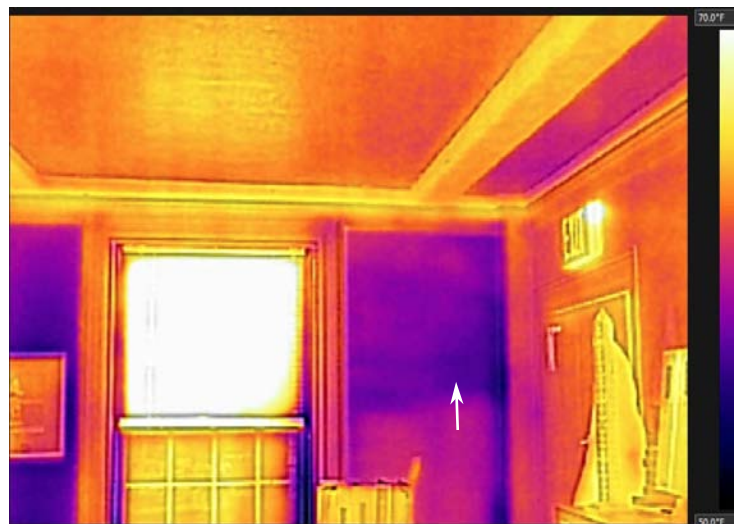
The next images show what would often be interpreted as loose insulation which has settled down leaving a void

Though it isn't clear what it indicates in this context

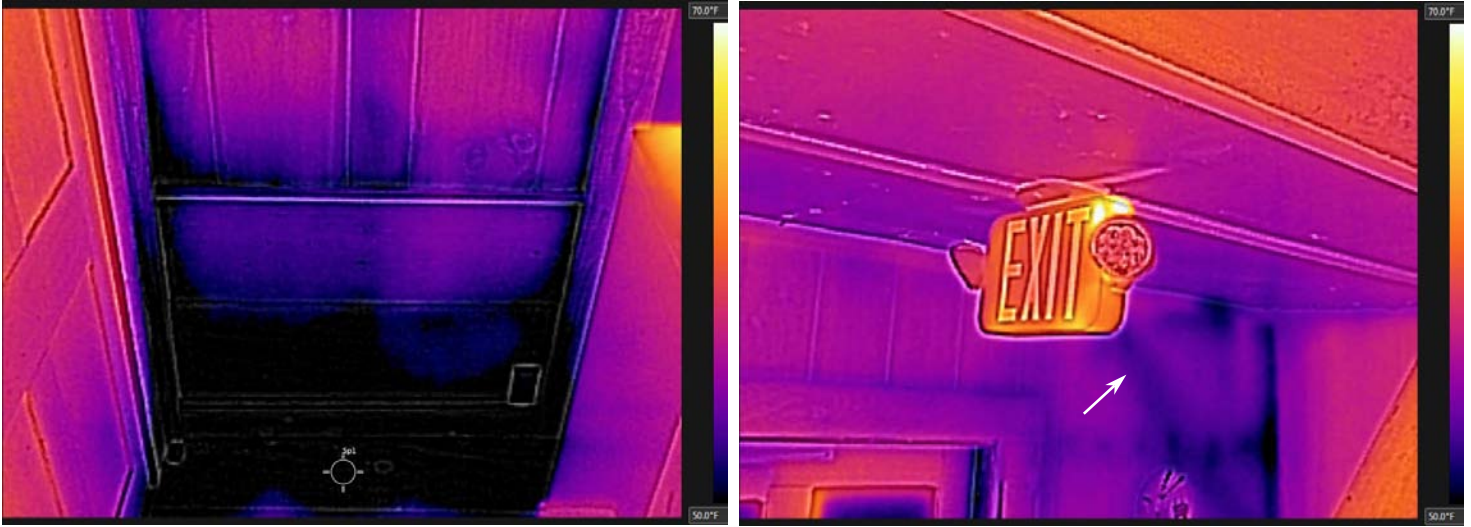
Connecting corridor, front door, stairway:

As usual a somewhat leaky door, though the temperature at the bottom is 47°F. Wall temperatures in this area are in the mid-50's. The wall cavities appear to be insulated - note the cold stud/brace next to warmer cavities.

The cavity insulation and lower inside temperatures are consistent with the outside image on page 2 which shows lower heat loss (lower temperature) in this area.

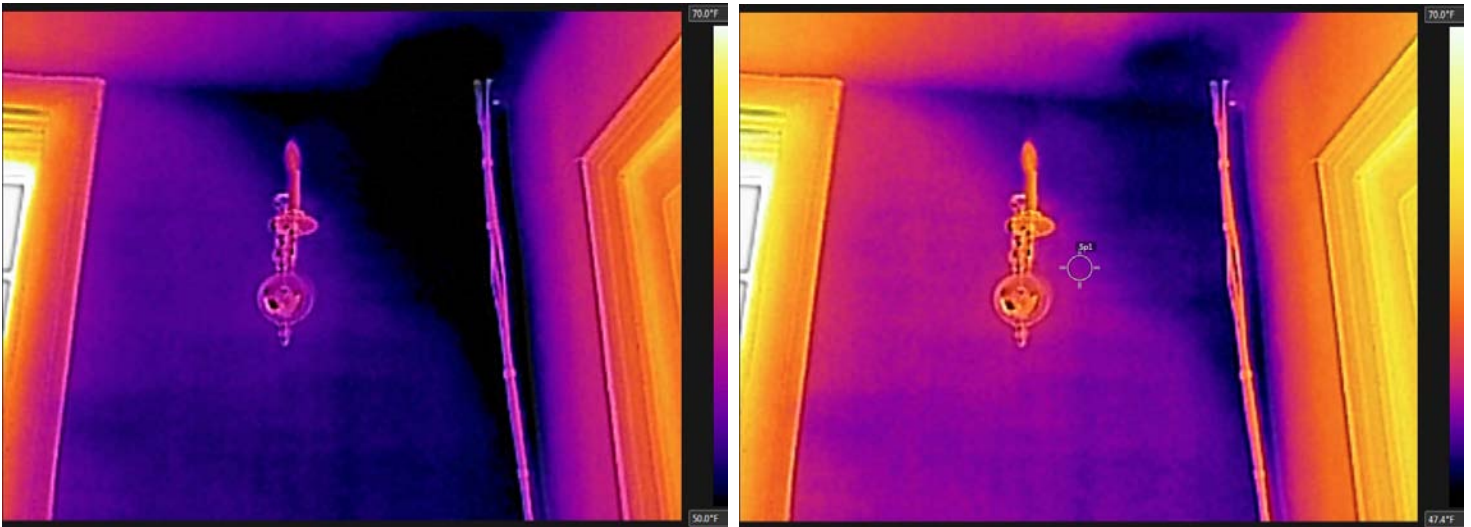
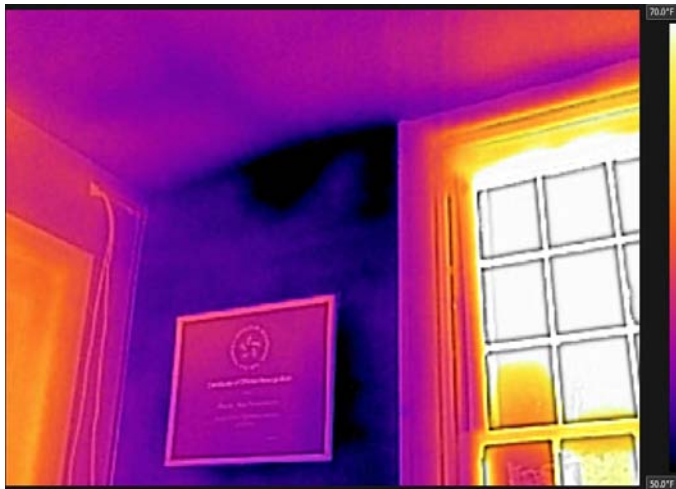
At the top of the stairs the wall temperatures are around 52°F, with the cold spot in the upper right at 48°F.

Except for the suggestive triangular region in the upper right corner, there isn't visible evidence of stud versus cavity differences.

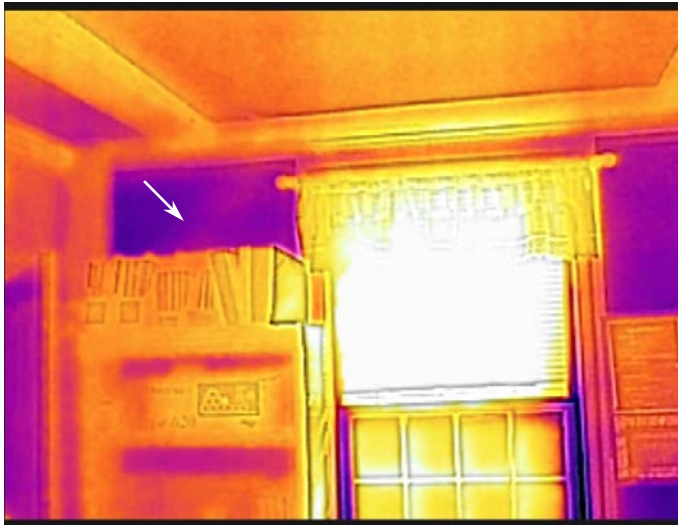
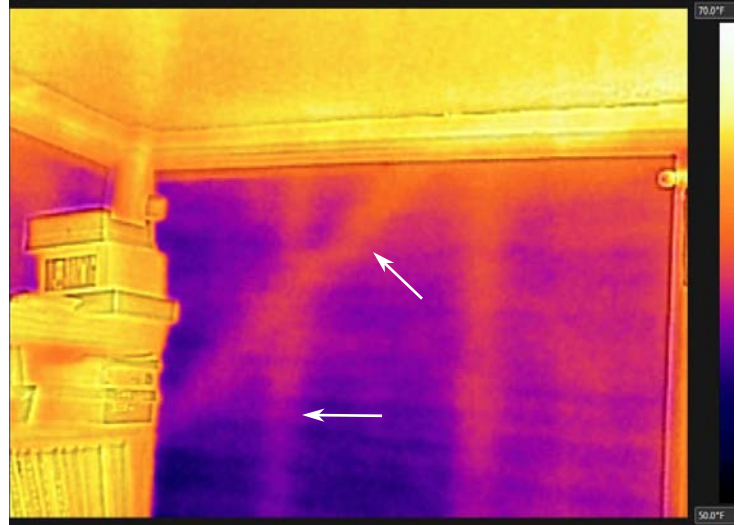
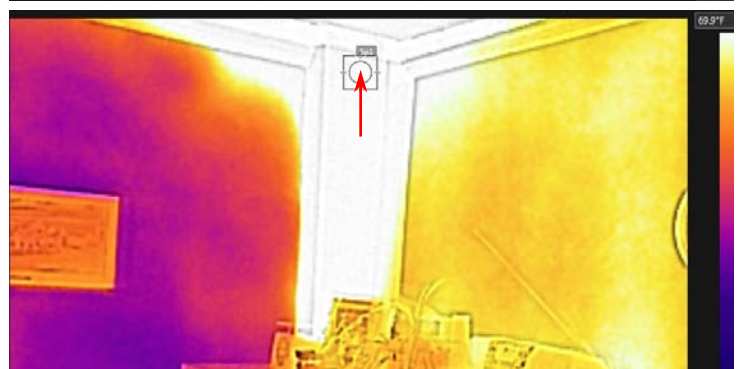
Town Clerk and Tax Collector's office:

Both outer walls are clearly not insulated as shown by the hot stud / cold cavity pattern. All 3 images shown use Equalized color scale to highlight the stud/brace to cavity contrast.

The surface temperature of the outer walls ranges between 58°F to 61°F over most of the area.

The inner walls, and the ceiling are around 68°F.

The white vertical column shown at the right is a pipe chase covering a pipe (or pipes) carrying hot water from the heating system to the upper floor. Temperature at the chase top is 80°F (see red arrow).

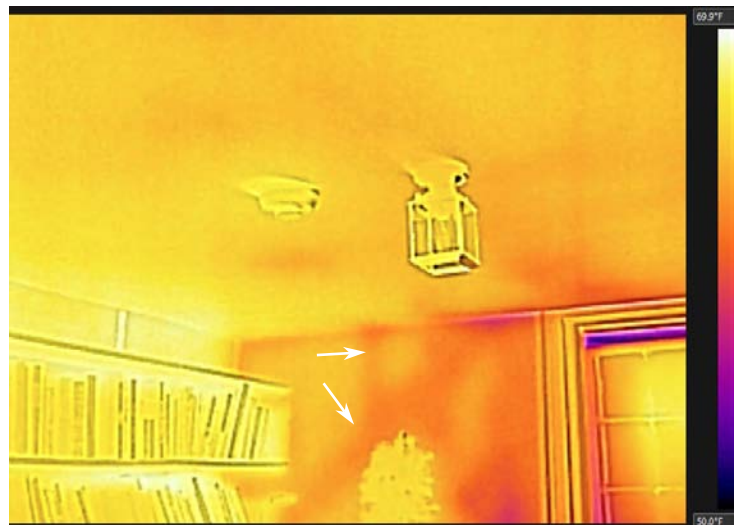
Second floor: Library overflow room:

The first room at the head of the stairs from the main meeting room is the "Library overflow" room. Note the clear evidence of insulated cavities - cool (62°F) studs/braces between warmer (66°F) cavities.

Since heated air rises, much heat is lost from the poor sealing on this floor. At a minimum all windows should have latches, broken or cracked panes should be replaced and inspection done to ensure that all storm windows are in position. Replacing single pane with modern double-pane insulating windows would help greatly.

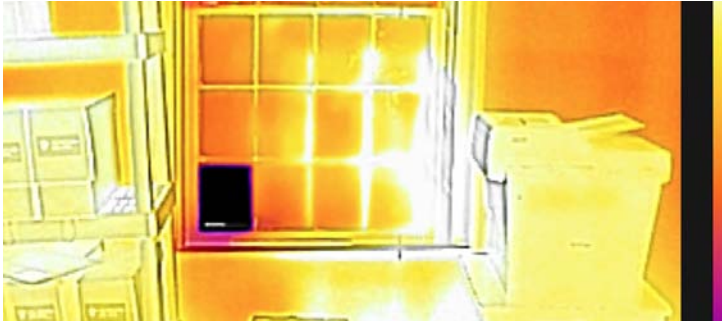
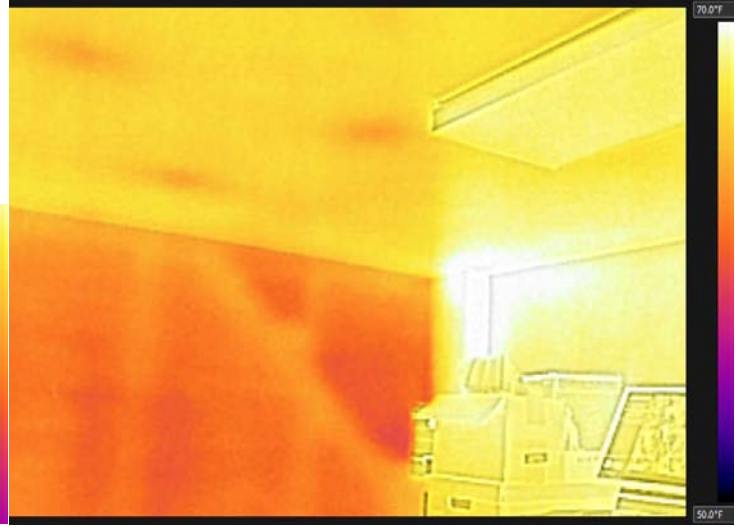
Second floor: File storage room:

Note the evidence of **uninsulated** cavities - warmer (62-63°F) studs/braces with cooler (60-61°F) cavities.

Interior walls, the ceilings, and objects inside are around 66-68°F. Note the missing window pane!

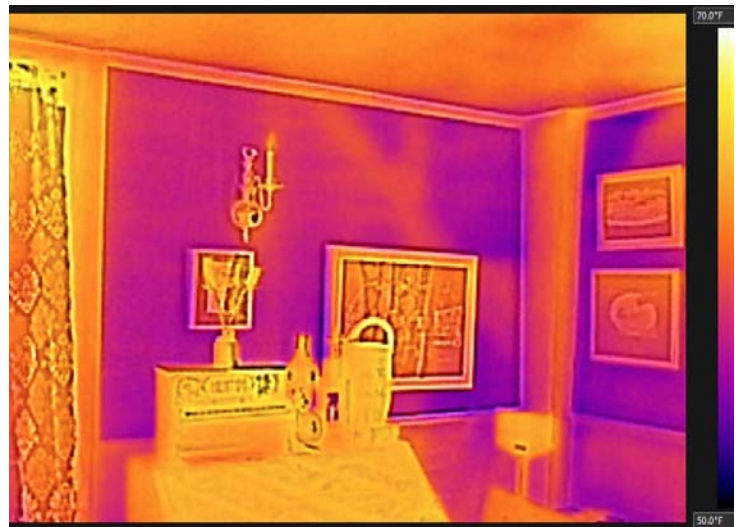
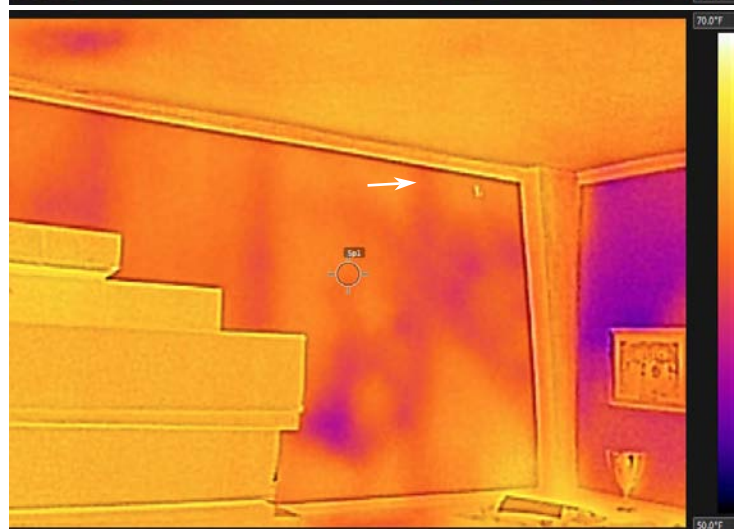
Second floor: Historical Society room:

Wall insulation varies. In the image to the right the cavities are clearly not insulated.

However, the second image shows insulated cavities in the wall at the left, and uninsulated ones around the corner in the walls to the right.

Wall temperatures vary from 55-62°F (purples to dark oranges). Free-standing objects are generally around 64°F, indicating the air temperature. There are a few cold spots below 50°F.

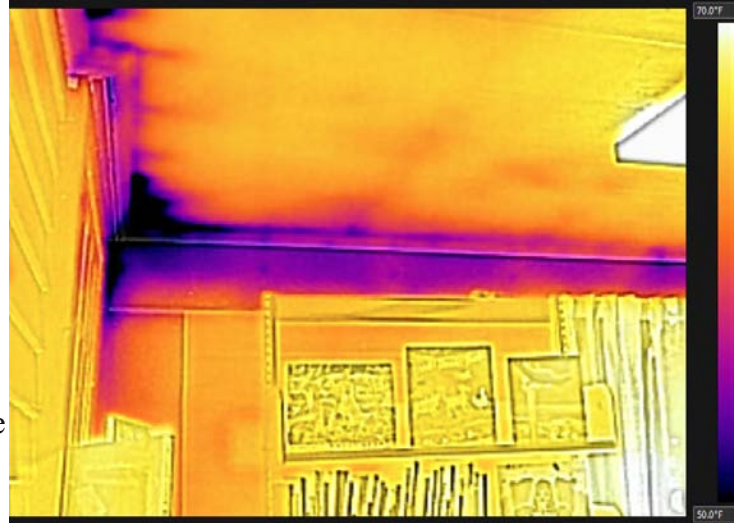
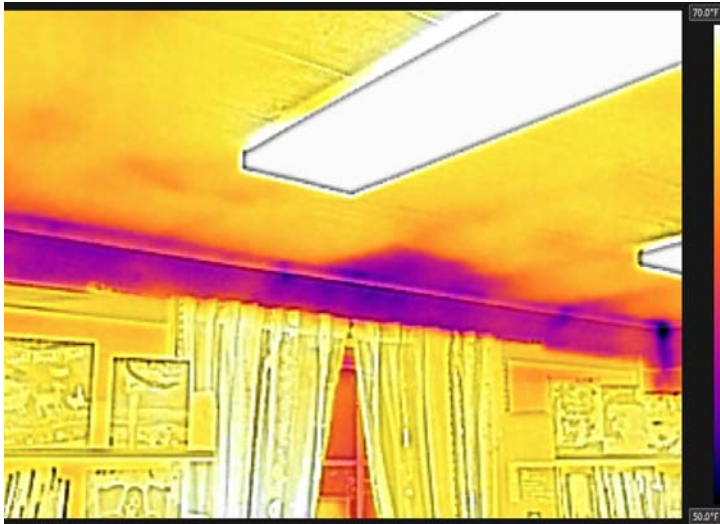
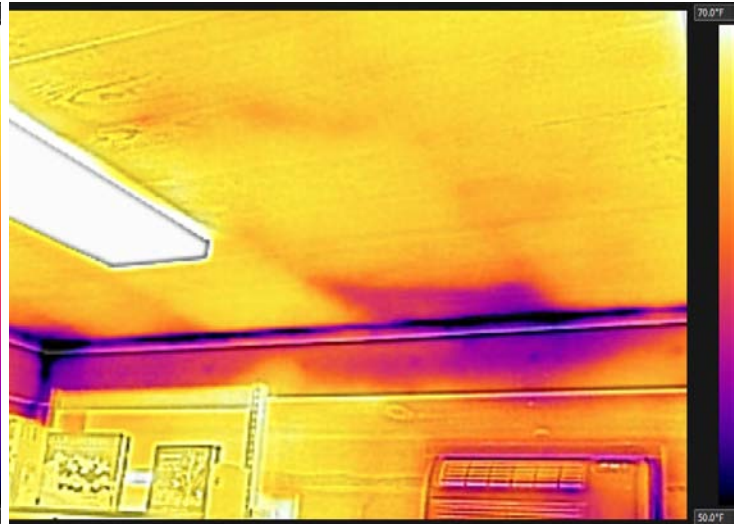
Library : children's room:

There appears to be a substantial heat leak in in upper left corner, which is around 38°F compared to the walls and ceiling which are at 64°F. Perhaps cold air inflow?

There consistently are similar, although not as extreme, heat losses along the joints between the wall and the ceiling all around the external walls. Temperatures in these black-colored areas are as low as 45°F while the walls and ceilings are ~ 64°F. See images below.

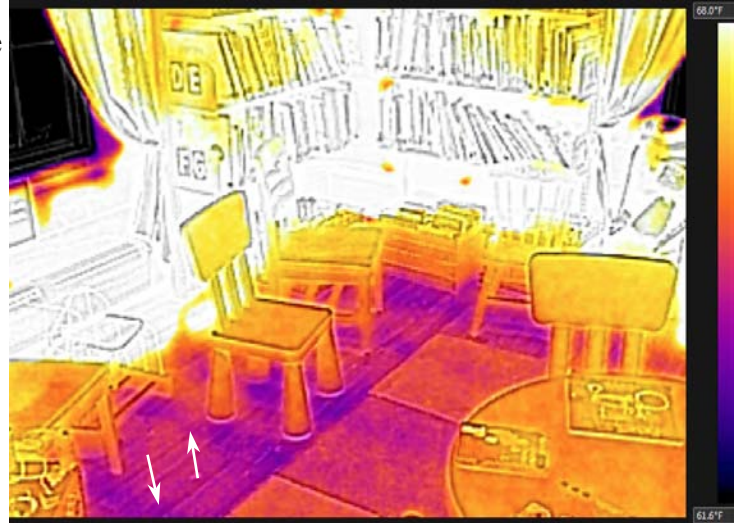
The equalized image to the right shows a narrow 9°F range to maximize the "contrast". The pattern of cooler joints and warmer areas between indicates that the floor is properly insulated.

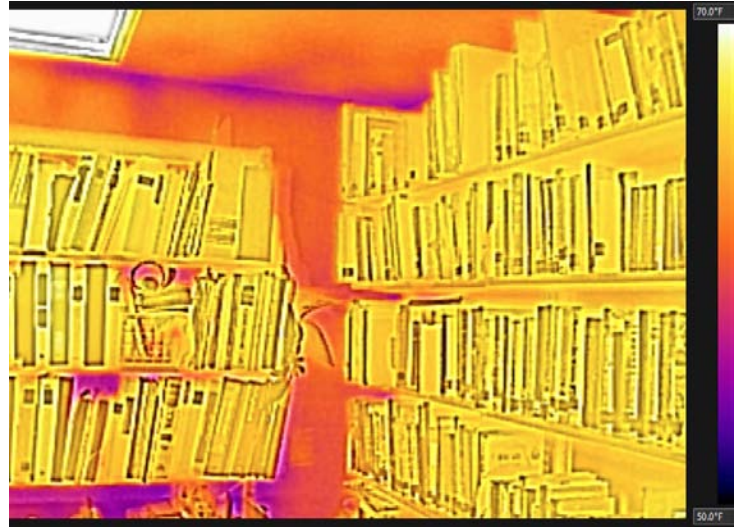
Library: upper floor:

Too much of the walls is covered with bookshelves to see a stud/cavity pattern, but there is no indication of any lack of insulation.

Wall temperatures are around 60°F, the ceiling around 62°F, the floor and standing objects around 66°F, suggesting an air temperature of 66°F.

Walls behind rows of books will run cooler because of reduced access by warm room air. This can be seen in the purple areas just above the rows of books.

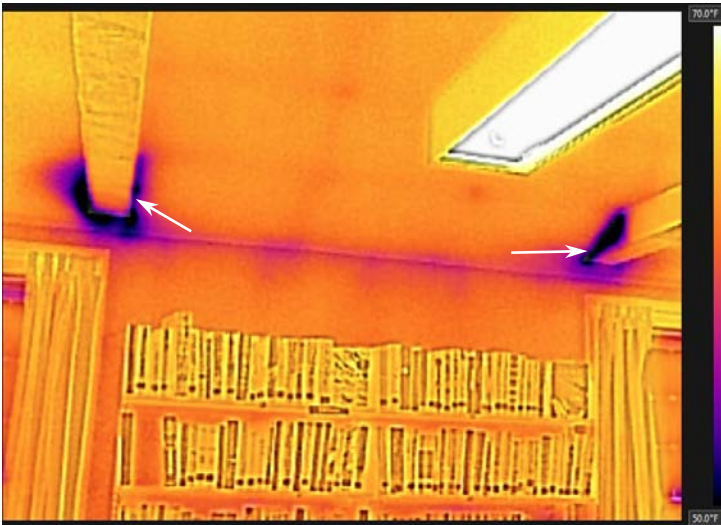
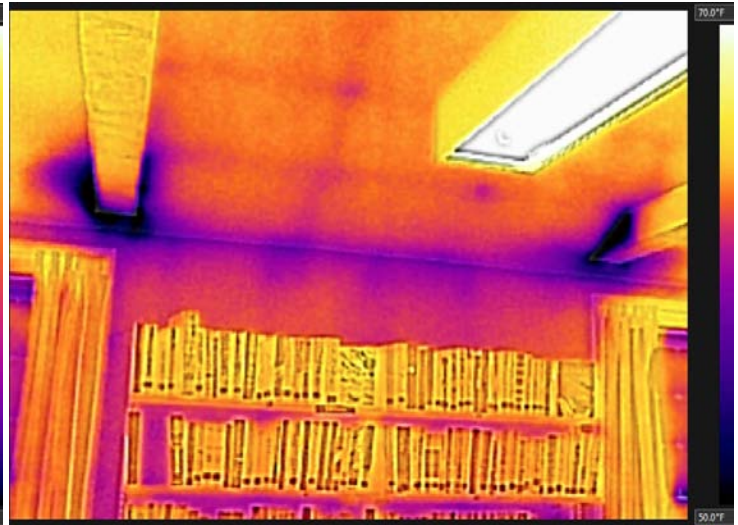
Library: lower floor:

Heat leaks are found where each tie beam pass through the ceiling. The temperatures in these areas can be as low as 39°F, though more commonly around 45°F. This might be caused by inflow of cold air?

The cooler stud and warmer cavity pattern that indicates cavity insulation can be seen above the top book row.

Wall temperatures are around 62°F, ceilings 63-65°F, floors 60-62°F, standing objects ~ 64°F (air temp)

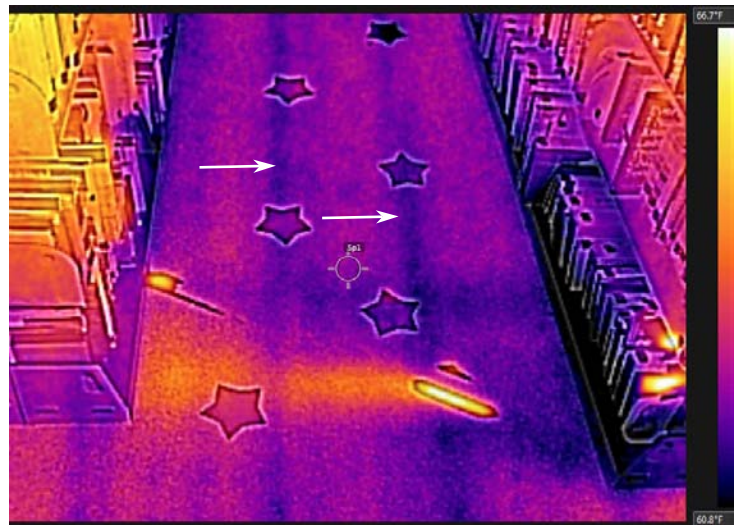
The cool joist and warm cavities shown in the Equalized image with a narrow 5°F range shows that the floor is insulated.

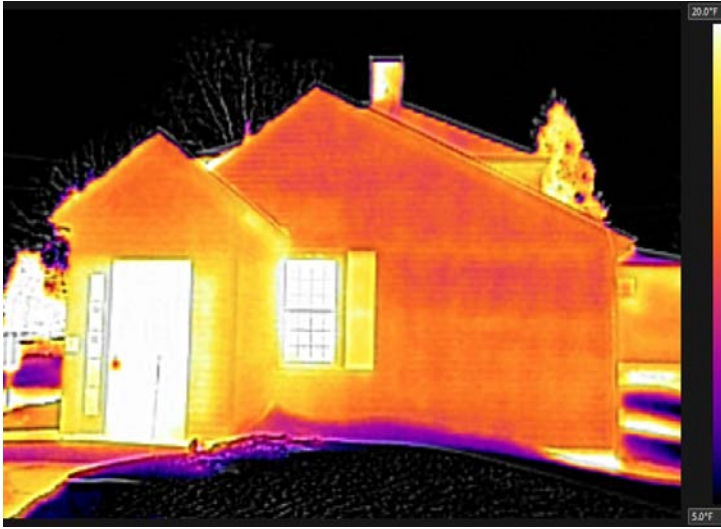
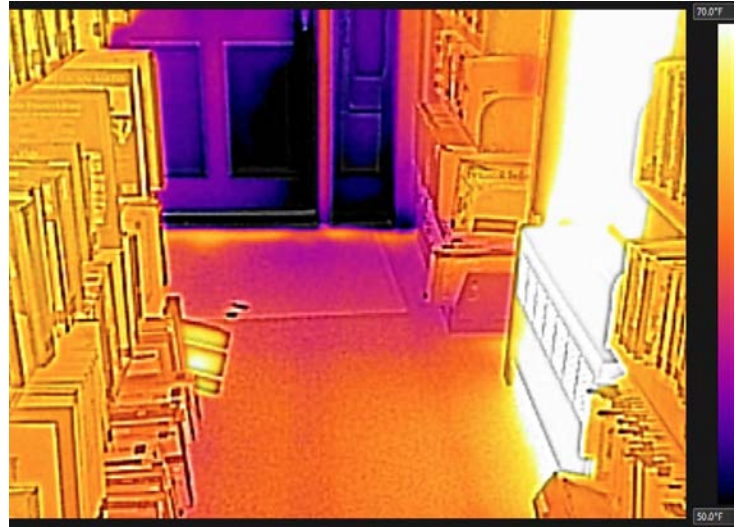
The exit door is rather cold, 45°F at its lower edge and 55°F at its middle panel. This seems surprising as it is opening into an enclosed passageway to the exterior door.

An exterior image (before sunrise), suggests quite a bit of heat loss from this exterior passageway and door.

I did not observe whether the passageway itself is heated, but I assume it is not. I would have thought that two doors separated by a wide airspace would provide better insulation than is indicated by the low temperature of the inner door.

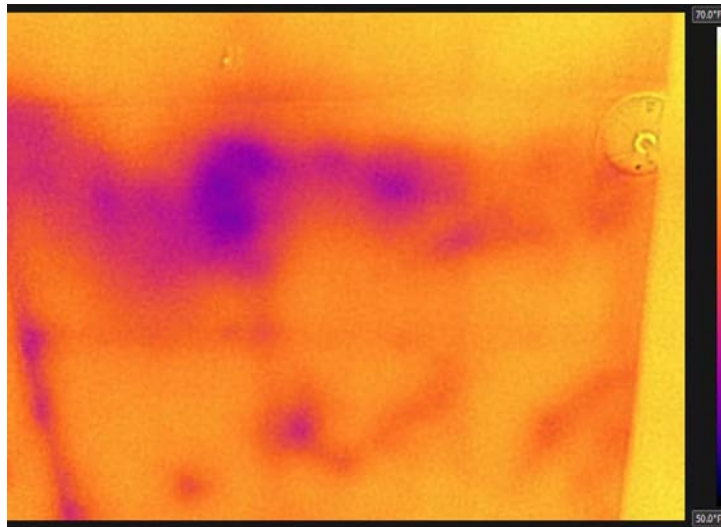
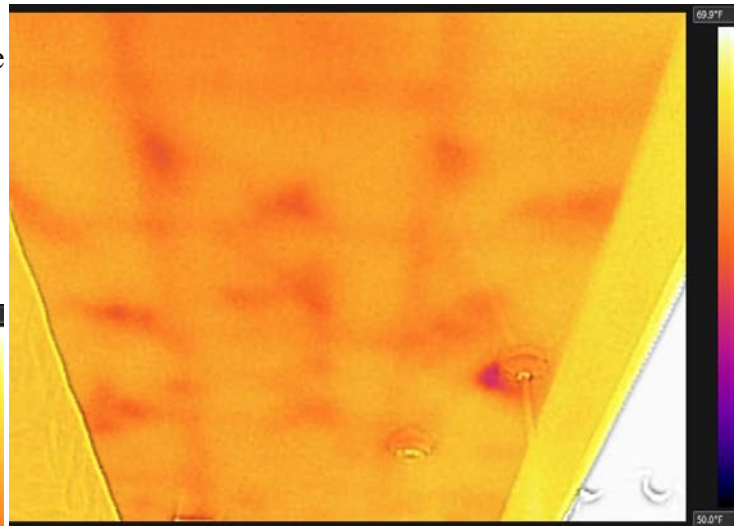
A curious "mottling" can be seen in several places in the ceiling of the lower library room. This reflects a difference of near 4°F between the spots and the rest of the ceiling (and 8°F difference in the lower image). One can also see the support grid.

Such mottling often results from thin spots in loose insulation, or moisture from roof leaks or condensation.

Cause is not obvious, but might be worthing thinking about...

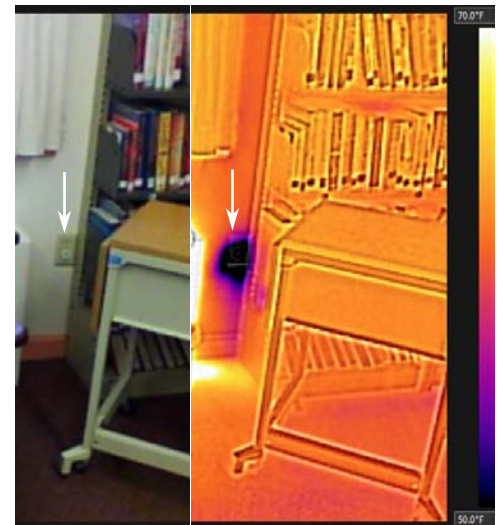
Finally, an example of an uninsulated outlet (one of several wall outlets and switches throughout the building). The nearby wall temperature is over 60°F while the outlet face is 43°F, low enough to condense moisture from the air and create conditions for corrosion of the electrical fixtures inside. Modern construction standards provide for boxing in and insulating in-wall electrical boxes to prevent such problems.
