# A Study of Mason's Borders

Garth Fletcher  
Mason, New Hampshire  
May 2020

This is a personal project motivated by curiosity rather than a specific purpose [1]. It was enabled by the availability of powerful open source GIS software (QGIS) plus the extensive public GIS data files from NH GRANIT and MASS-GIS.

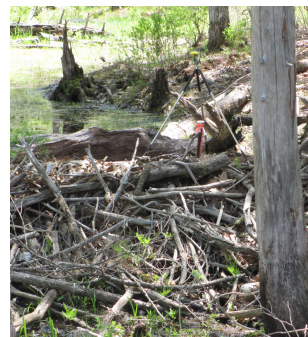
12 SM IP Gillman Hill Rd

*Note: a Town Line monument is indicated on USGS Topo maps on the N side of Gillman Hill Rd, but could not be found. Long-time town employees report having last seen it many years ago. HCRD Plan #8062 (1974) references it.*

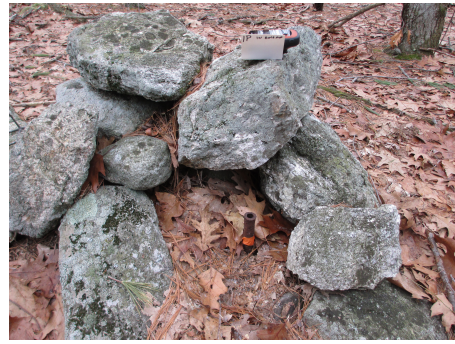
## The Mystery of State Line Monument #59

**LEGEND:**  
 Background: USGS Topographic maps from GRANIT raster files  
 Black circles + crosshair, #1..10: monuments, located ±3 feet using GNSS receiver.  
 Blue circle + crosshair, #59: IP in stone semi-circle, located ±3 feet using GNSS receiver.  
 Thin magenta dashed lines: parcel lines  
 Heavy dashed red line: state line per USGS shape file from GRANIT  
 Heavy dashed grey line: state line per MASS-GIS shape file  
 Thin green dashed line: monument to monument (1..10) straight lines  
 Small red circles and stars: stone walls detected in orthophotos (circles) and LIDAR data (stars); suggestive of parcel lines, etc.

Note close correspondence between monuments and MASS-GIS state line shape files.

SCALE: 1:2400 (1"=200'), Proj. EPSG:3614, NAD83(NSRS2007)/NH (ftUS) v2020\_04\_29

**59: (Spc) SLM\_59** *Note: a SLM #59 monument is indicated on the USGS topo maps, but no granite monument could be found. An old iron pipe within a semi-circle of stones was found at the indicated area, see page 15, "The Mystery of State Line Monument #59". As this IP location lies on a straight line between SL monuments #58 (#4 on map) and #60 (#5 on map), I assume that it was set during the original 1894 survey and noted on the topographic map, but never replaced by a granite monument since it would not mark any line intersection or transport corridor.*

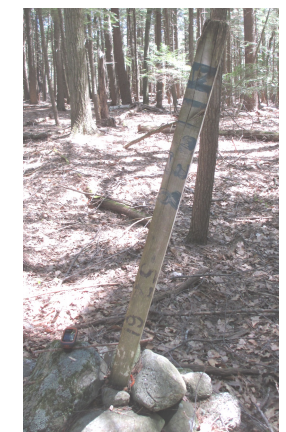
**73:** (TLM) G-T-NI\_Gvl\_NW\_corner {*Greenville NW corner with Temple, New Ipswich*}  
NAD83 (2010) Lat, Long, OrthoElev(m): **42° 47' 11.39998"**, **-71° 49' 18.00840"**, 267.118  
UTM 19N N,E: 4740968.305, 269208.369  
Obs. File, Date, Duration: 73\_G-T-NI\_Gvl\_NW\_corner.obs, 2020-05-16, 0:48:35  
SIG-PPP(95%) Lat, Long: 0.34, 0.91 Err Ell (95%) 1.14 x 0.42 meters  
Access: from monument 72 above, walk ~ 600' W through woods to stake and stones

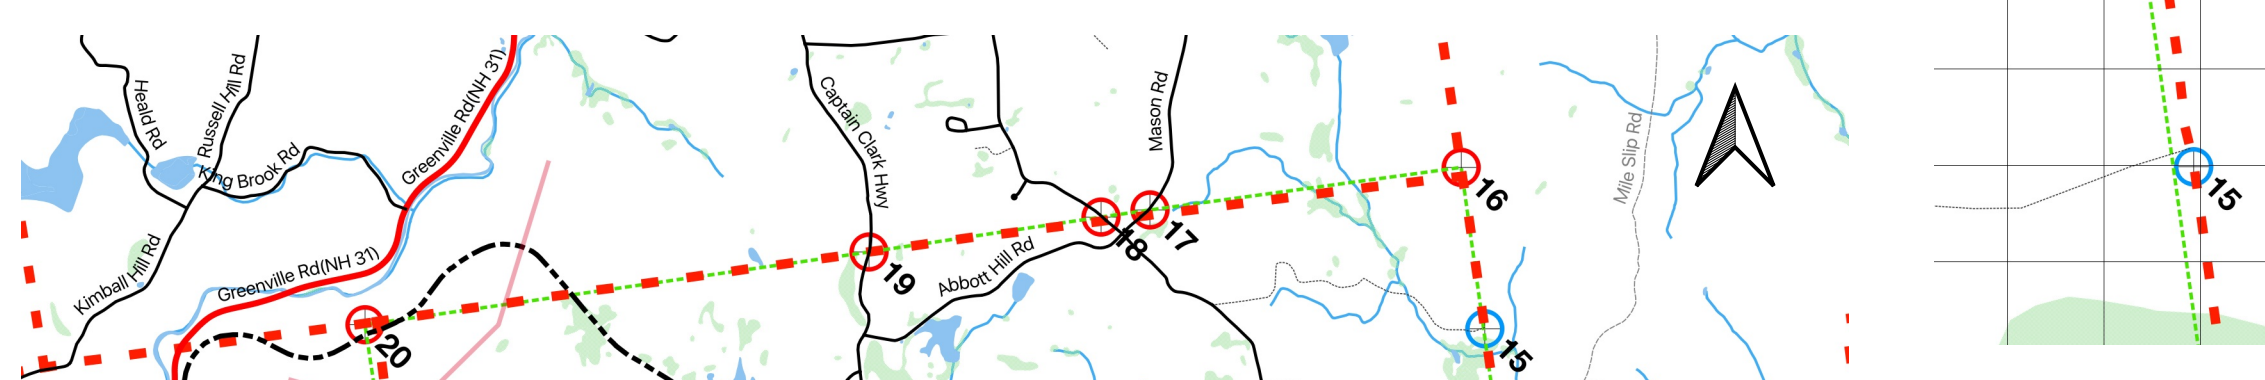
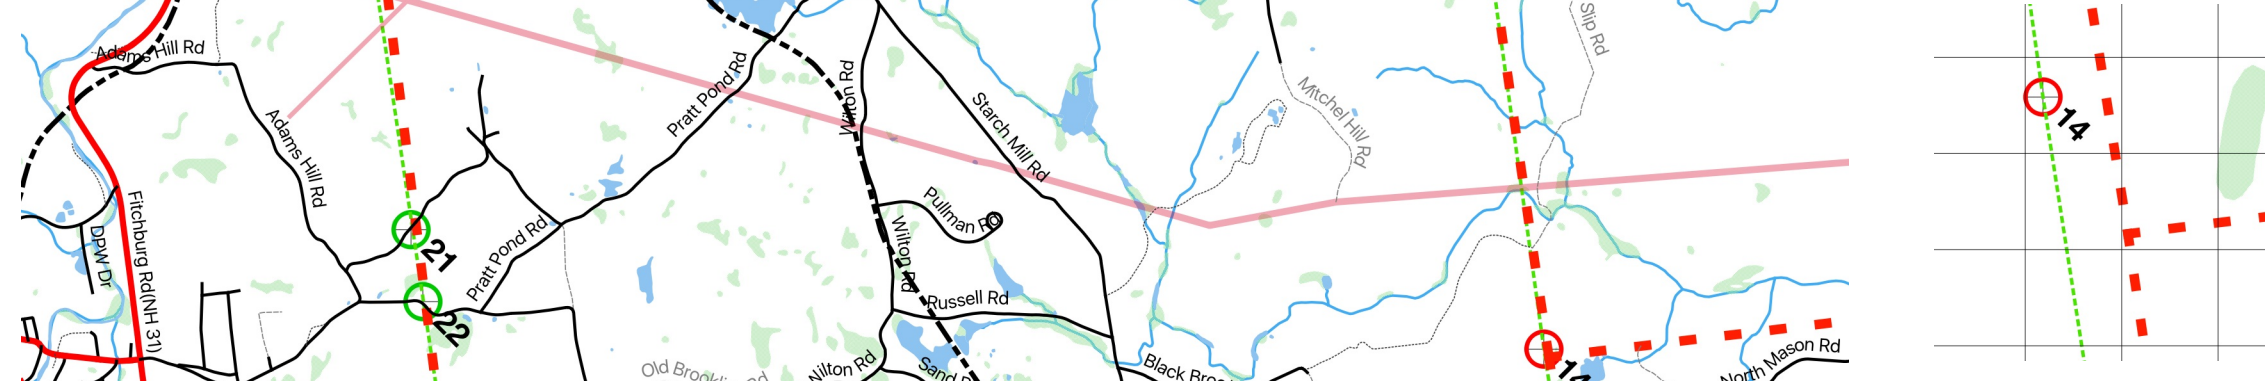
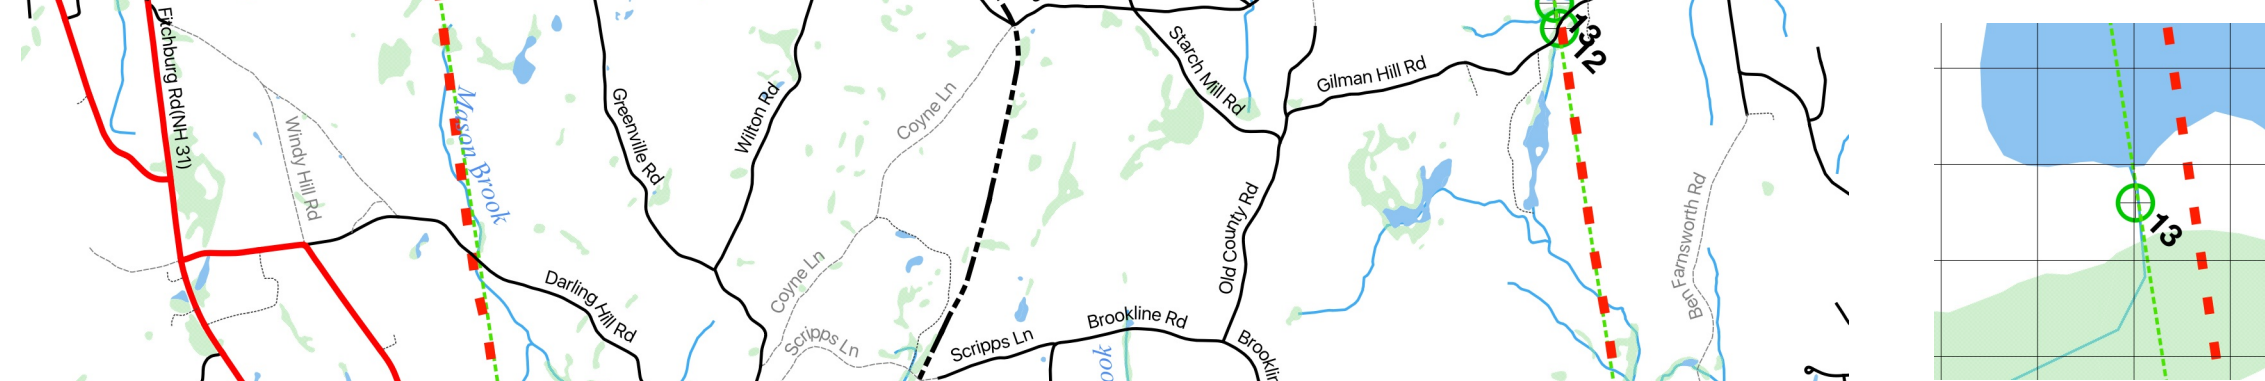
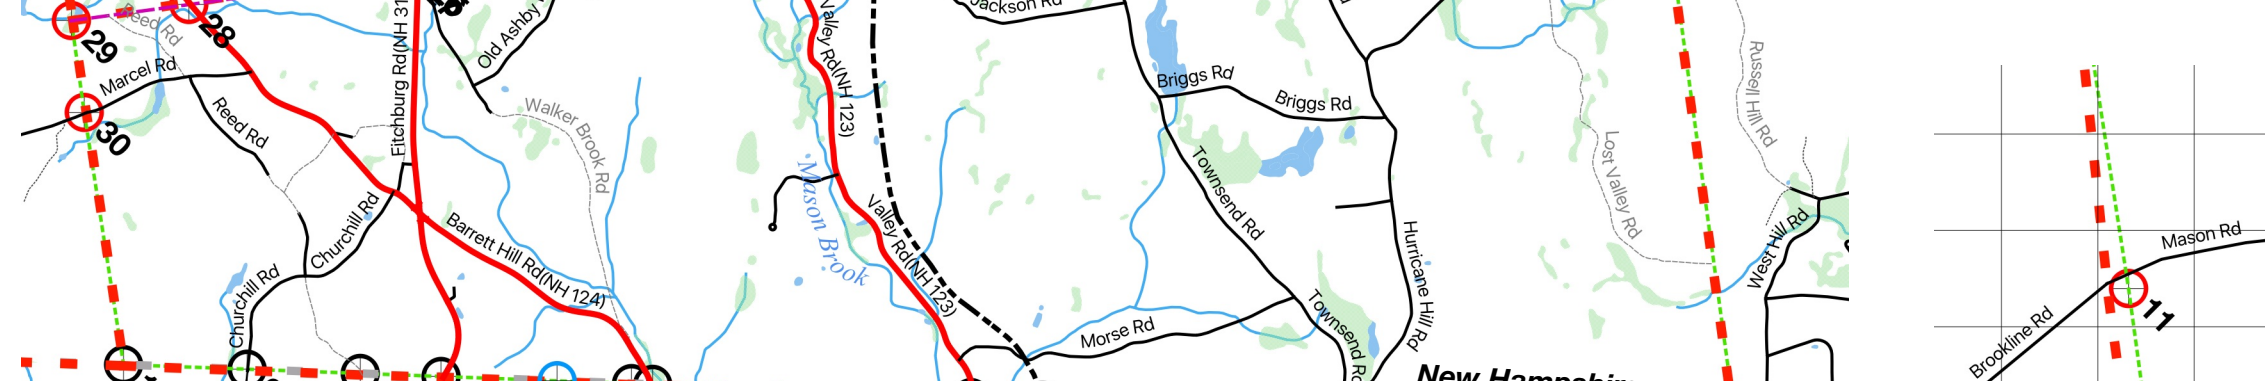
Map 1: Overview

30 "monuments" were found along the border. These are displayed as numbered color coded circles:  
 black: State Line monuments set in 1894, 14"x14" tall granite posts, #1 ... 10  
 red: Town Line monuments, various granite posts #25 ... 27  
 orange: NH Highway markers, low concrete posts (#25 ... 27)  
 green: survey markers (low granite posts or iron pipes) shown on HCRD plans  
 blue: #15, centerline of Conservation Commission gate in stone wall  
 #59, no monument found at location of #59 shown on topos, but IP found in stone semi-circle  
 The locations 1...30 are numbered in counter-clockwise order starting at Mason's SW corner.

Map projection: EPSG:3614, NAD83(NSRS2007) / NH (ftUS);  
 scale: main map 1:40,000, details 1:2,400

shows the locations of the monuments on a map of Mason (~ 1:40,000 scale) along with enlarged details (~ 1:2,400 scale) of each monument on a 100' grid.

The monuments are marked by circled cross-hairs, color coded to indicate the type of monument:

The town line, per USGS, is shown as a heavy red dashed line. The 1976 town line survey by Moran is shown as a heavy magenta dashed line. Thin green dashed straight lines join the State Line and Town Line monuments (but not lesser survey markers) to suggest the approximate location of the border.

Along Mason's Southern town line (1...10), the state line monument locations conform very well with Mass GIS's version of the town line (grey) while the USGS version (red) is slightly offset.

Greenville's Southern town line (#24-29), per USGS, aligns at its Western end (29) with Moran's survey, but is rotated approximately 0°55' counter-clock-wise, resulting in a ~ 160' offset NNW at its Eastern end (#24). This rotation is the source of most of the overlap between Greenville and Mason parcels discussed above along this border.

Mason's NW corner, per USGS, is offset by ~ 210 feet Eastward.
